**TEARDOWN AND INSPECTION OF THE CUMMINS  
VTA-903 - EVALUATED USING THE SINGLE COMMON  
POWERTRAIN LUBRICANT (SCPL)**

**INTERIM REPORT  
TFLRF No. 450**

by  
**Adam C. Brandt  
Edwin A. Frame**

**December 2013**

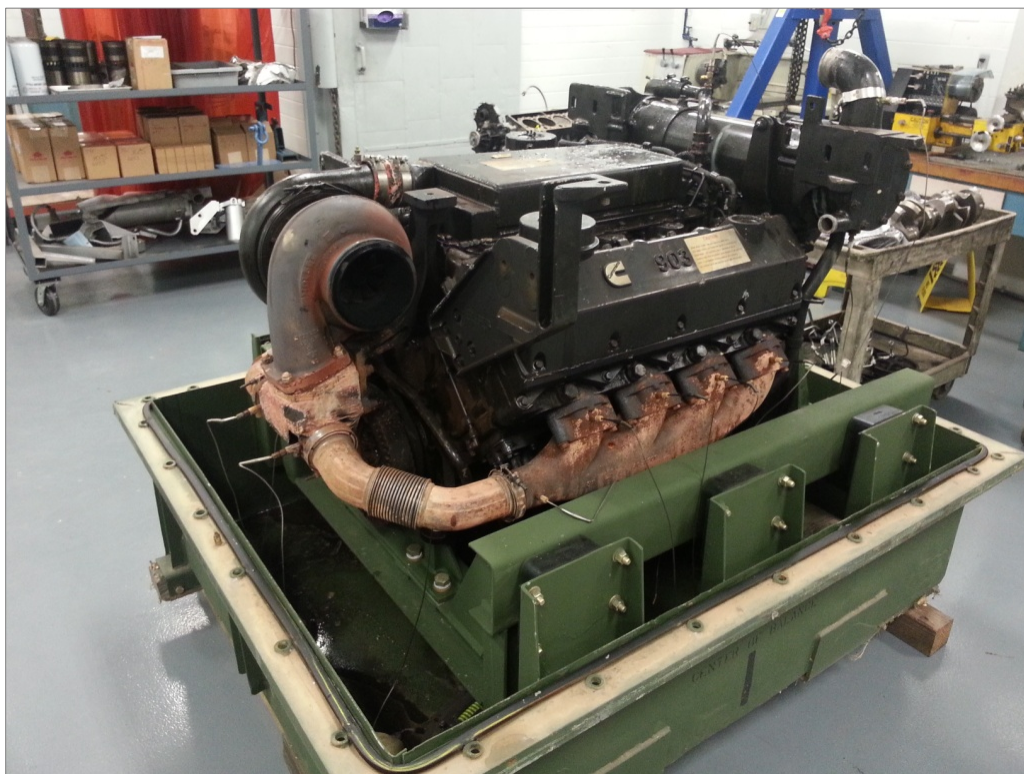
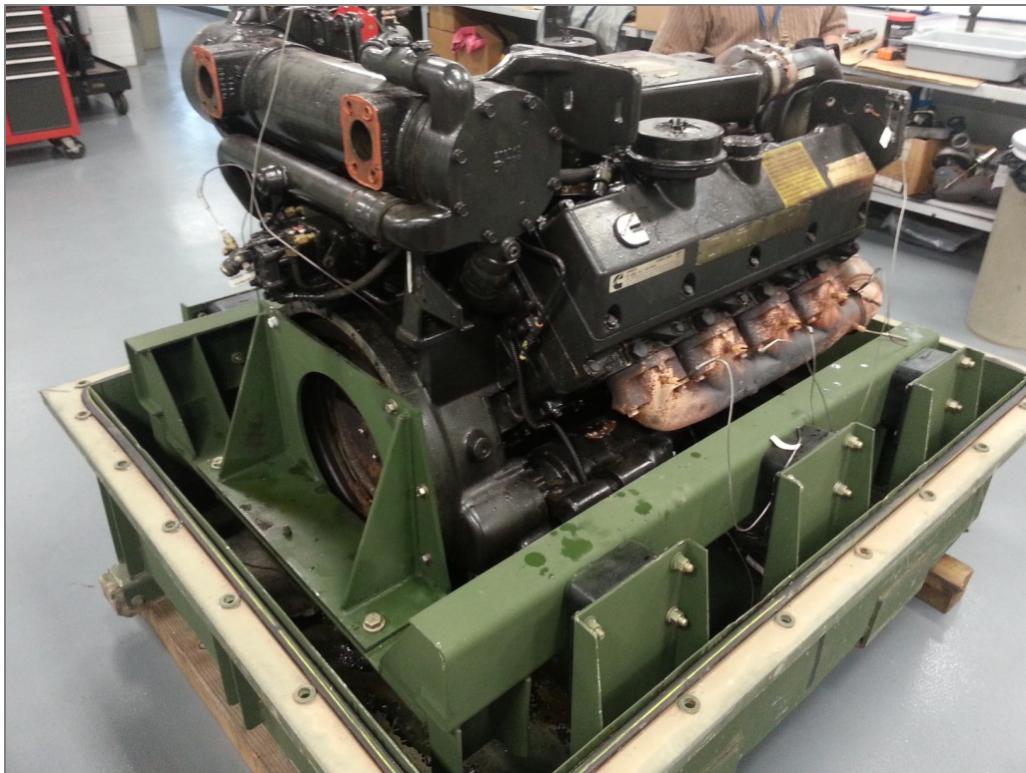
addition, excess used oil had accumulated in the bottom of the container which required cleaning prior to removal. The moisture present within the container was unexpected, and may have contributed to, or become apparent in some results reported within this report. Specific notations will be made in each suspected area. Figure 1 and Figure 2 show generic shots of the engine as received and uncrated at TFLRF. Figure 3 and Figure 4 show the moisture and oil present within the container upon opening.

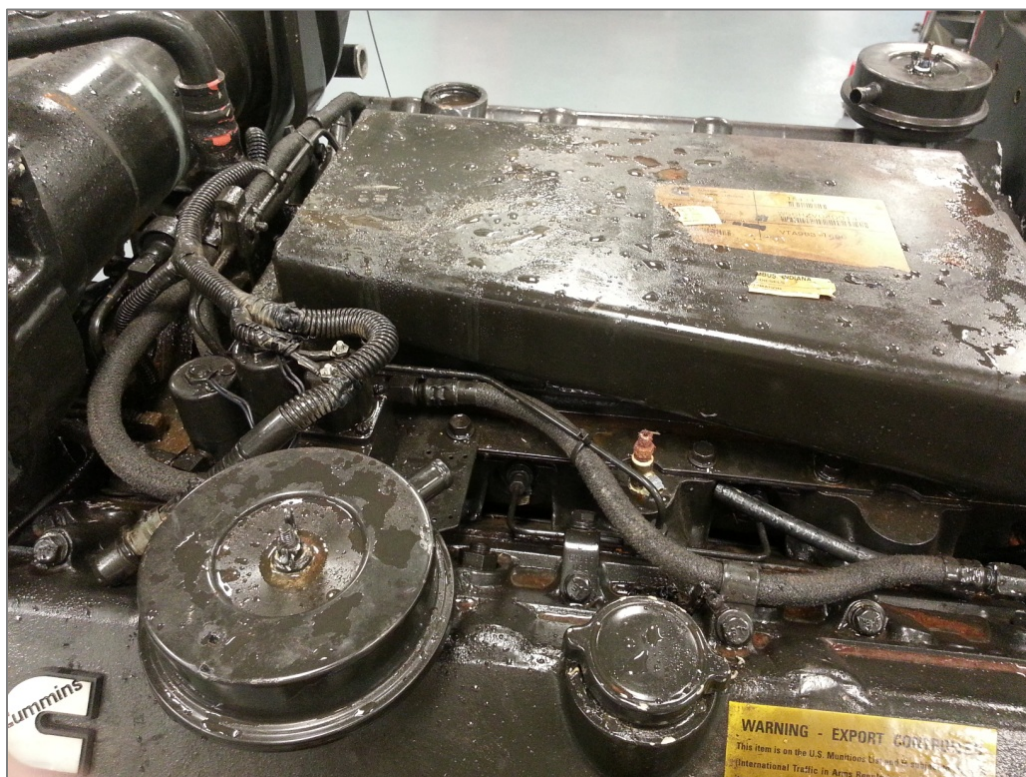
**Figure 3. Moisture Accumulated on Engine in Container**

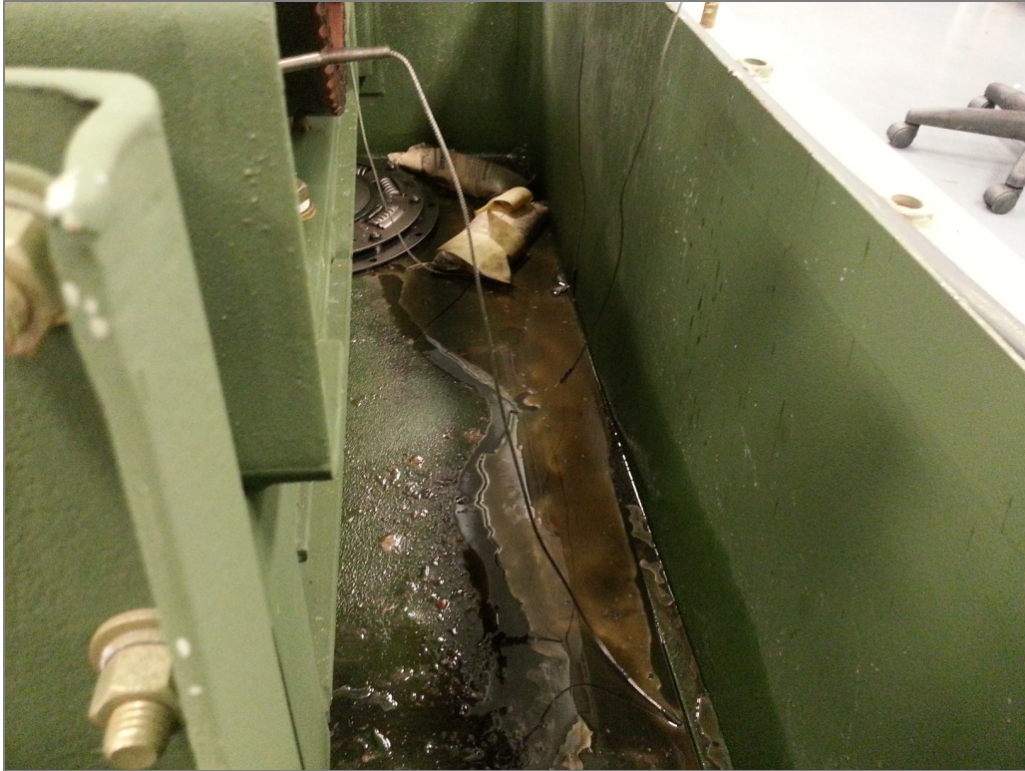
**Figure 4. Water/Oil Emulsion Present in Container**

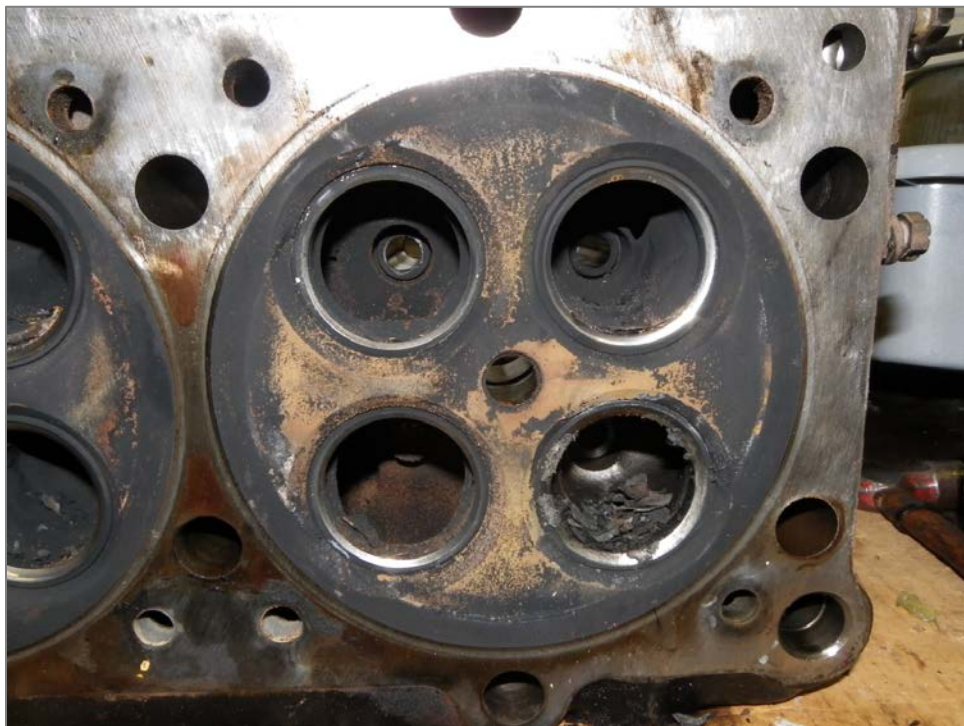
In general, we see a total average of 8.07 merits for the exhaust valves, and 7.93 merits for the intake valves. This again shows to be consistent with valve deposit ratings for the GEP development testing, and is overall considered a good result. Interestingly (and differently than the GEP testing), there was a propensity for a very light weight flaked carbon deposit to form in the intake valve tulips. This deposit formation was very light and fragile at the time of inspection, which resulted in a small collection of loose flakes in many of the intake port areas after cylinder head disassembly. As much of these deposits were retained on the valve as possible through careful handling, but with its overall fragility, some deposits did fall off of the valve before ratings. An example of this phenomenon can be seen below in Figure 5. Although present, these deposits do not immediately raise any cause for concern. At this time it is inconclusive if the valve tulip deposits were this loose immediately upon test completion, or if this is a result of the length of time the engine remained in storage between test EOT and teardown. Moisture apparent in the engine shipping container during storage could have contributed to the breakdown of more solid deposits on the valve tulips resulting in these light loose flakes, as with the fragility of these deposits, none would have been expected to stay intact while the engine was being operated. This further suggests the formation (or breakdown) occurred while the engine was in storage.

**Figure 5. Intake Port Light Flaked Carbon Deposits (Loose)**

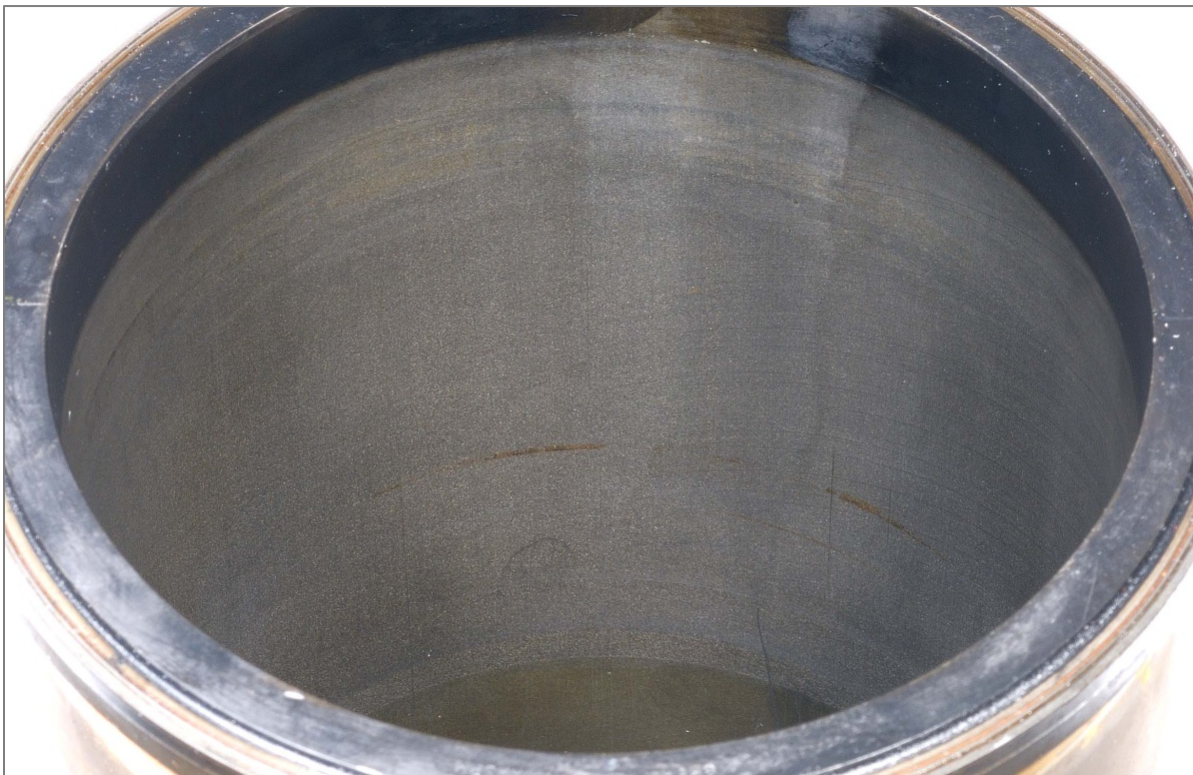
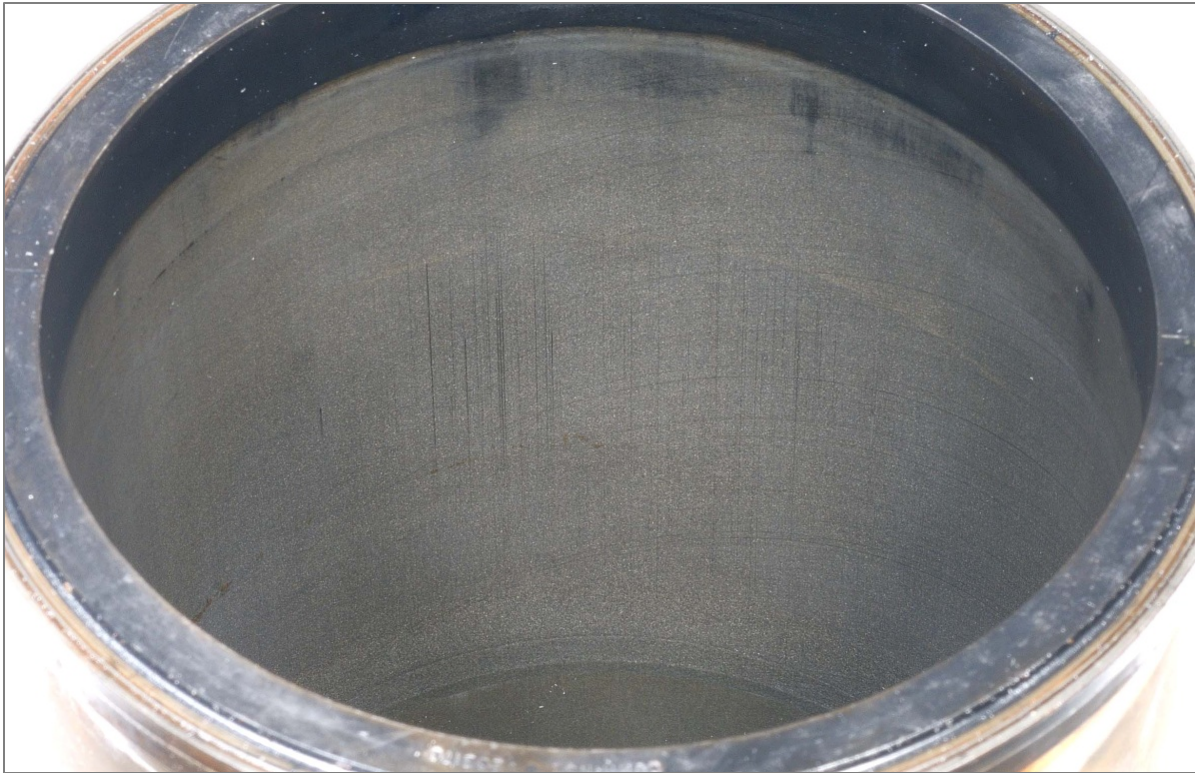
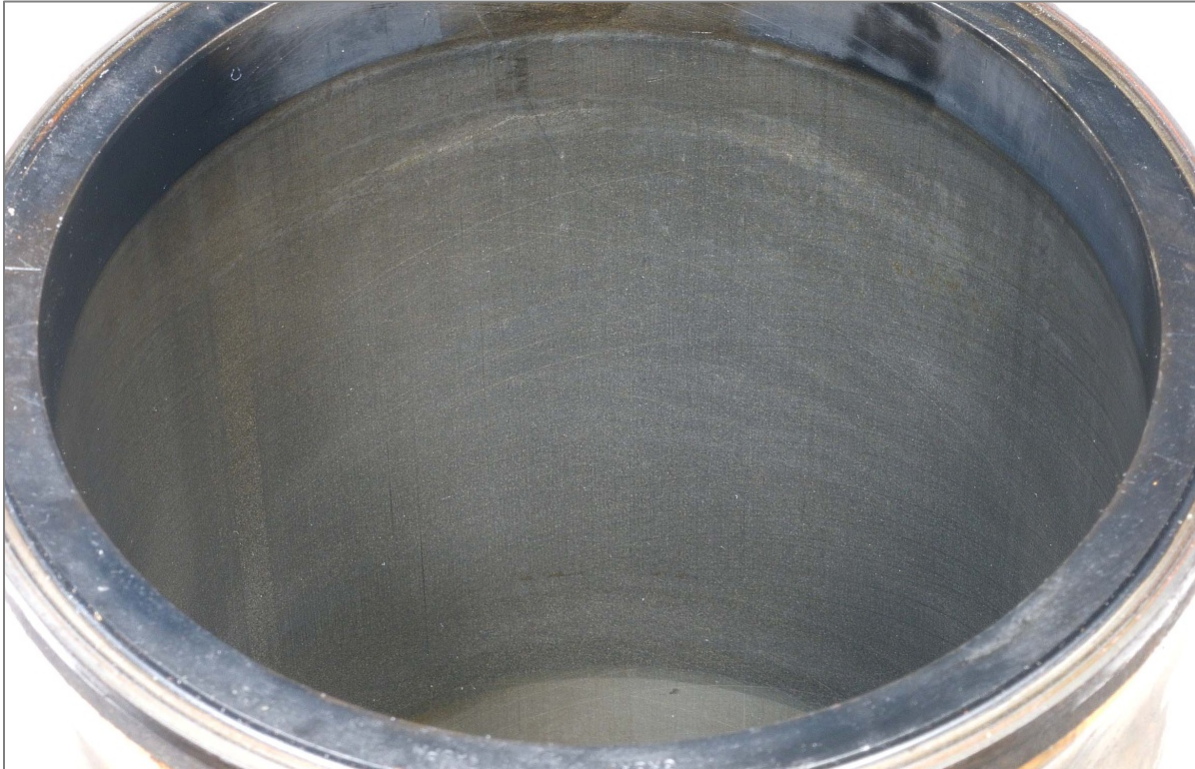
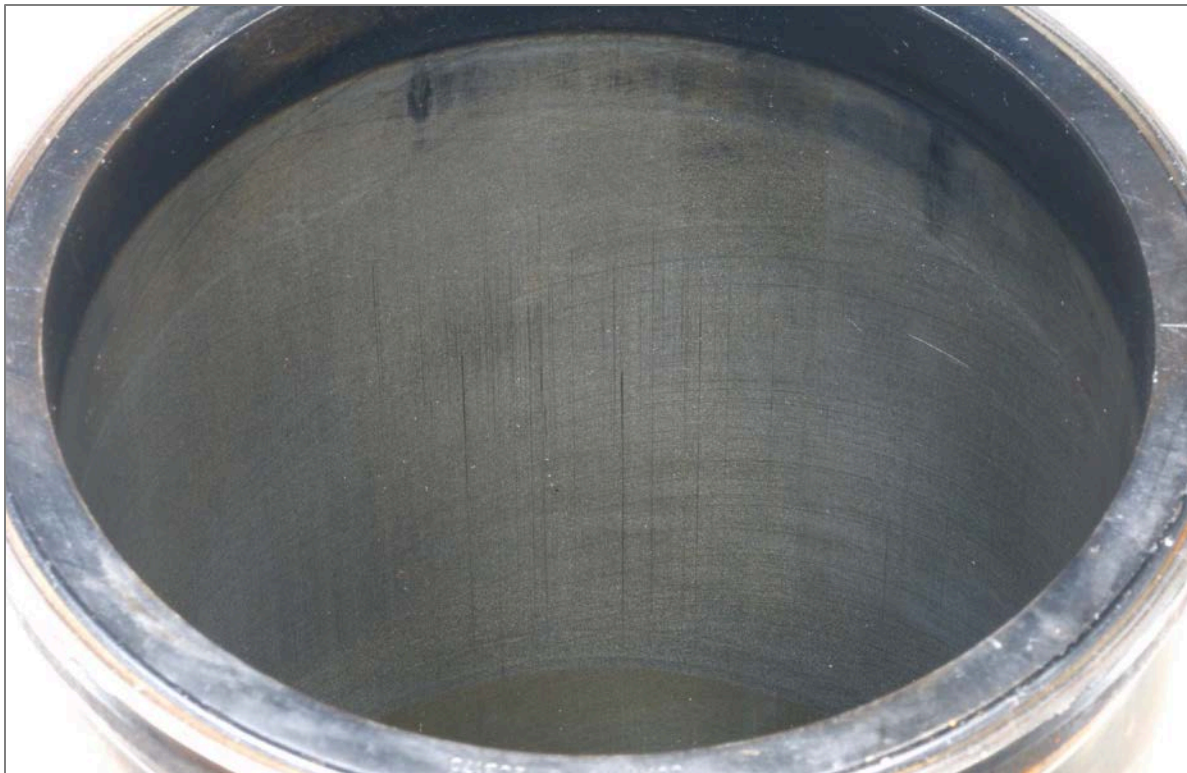
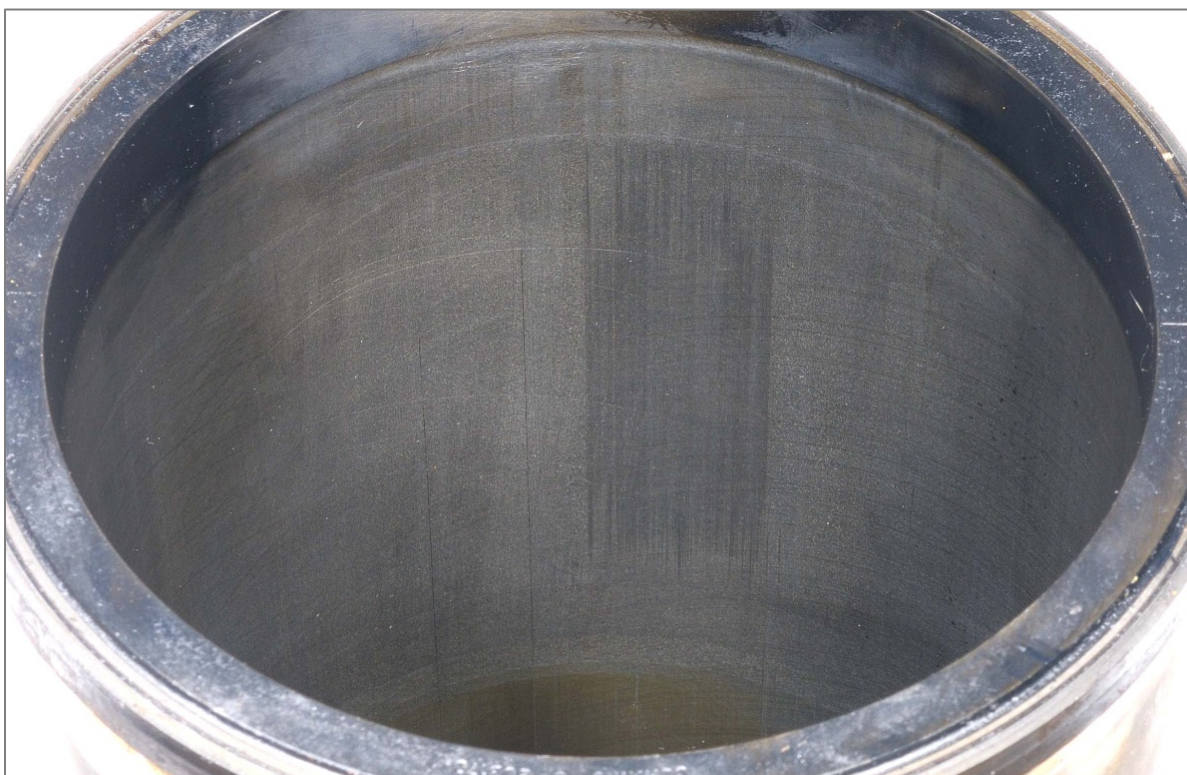
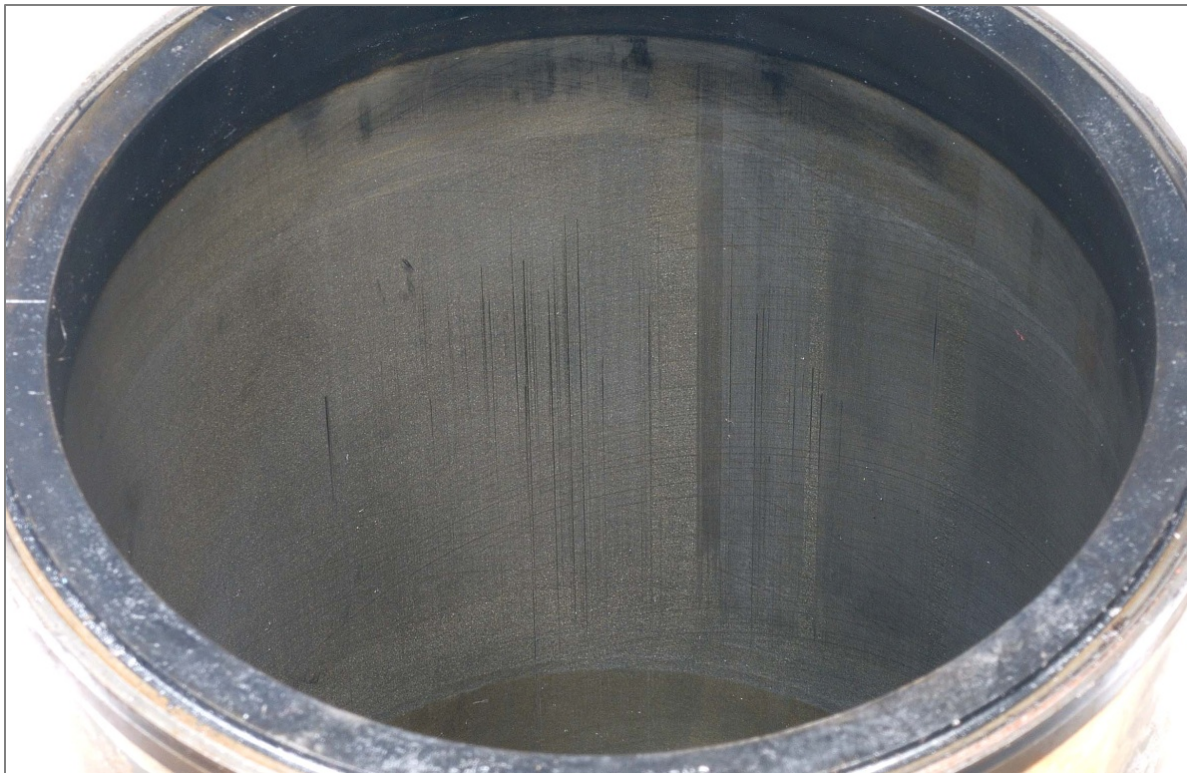
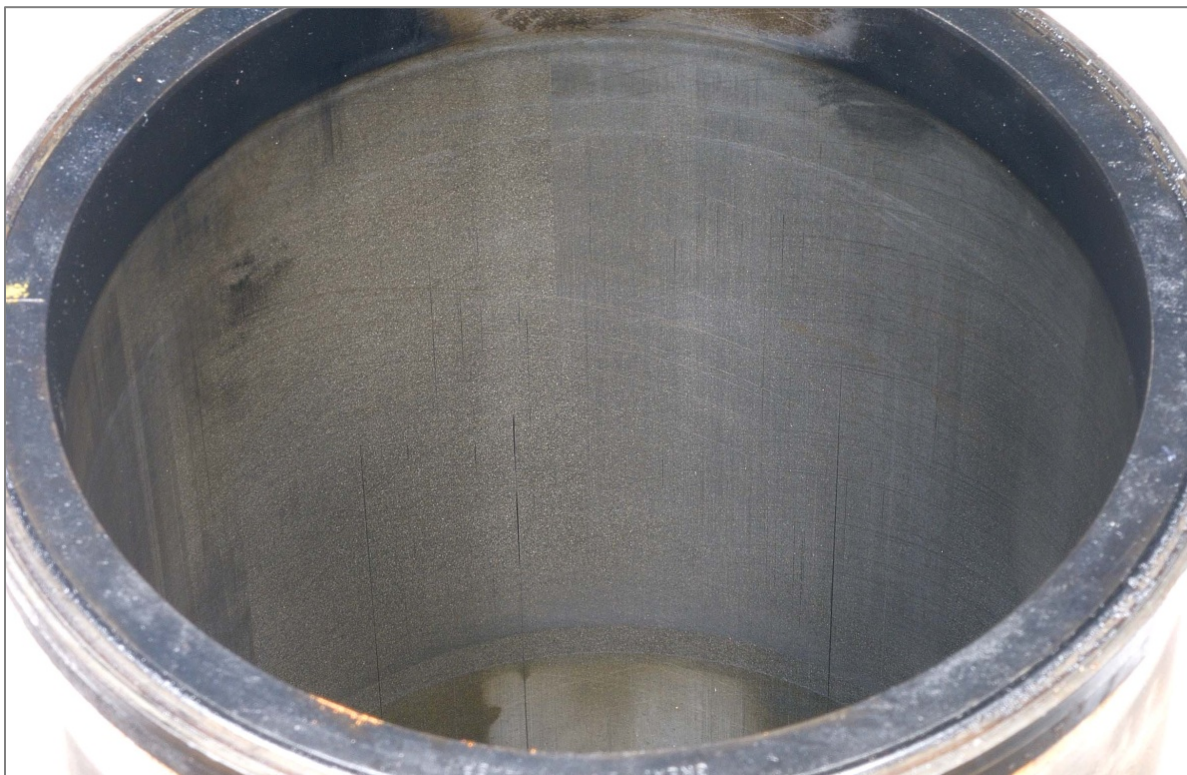
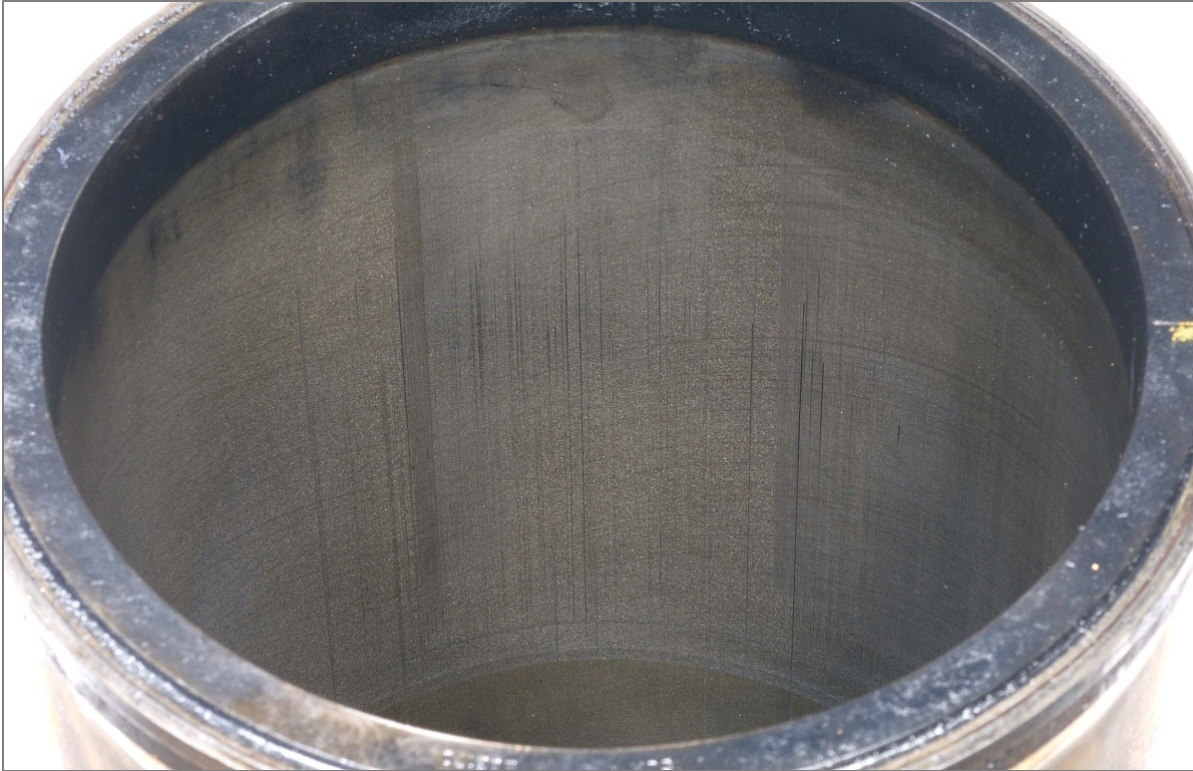
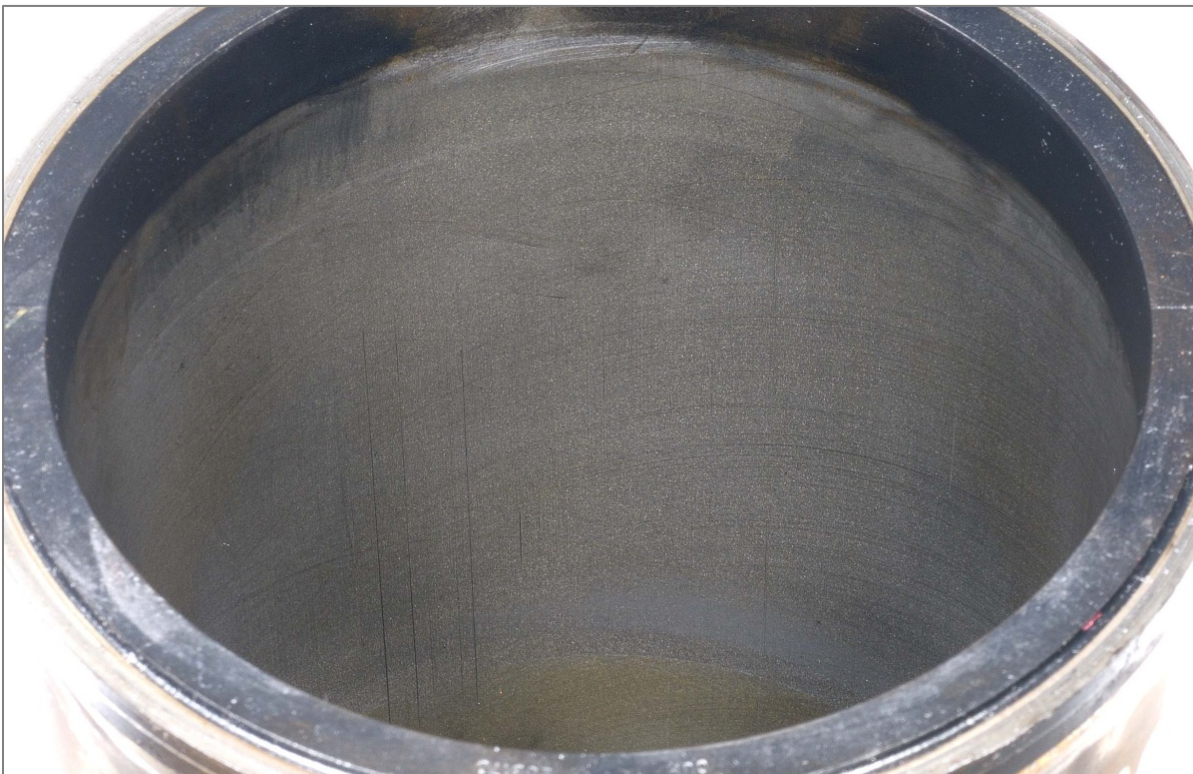
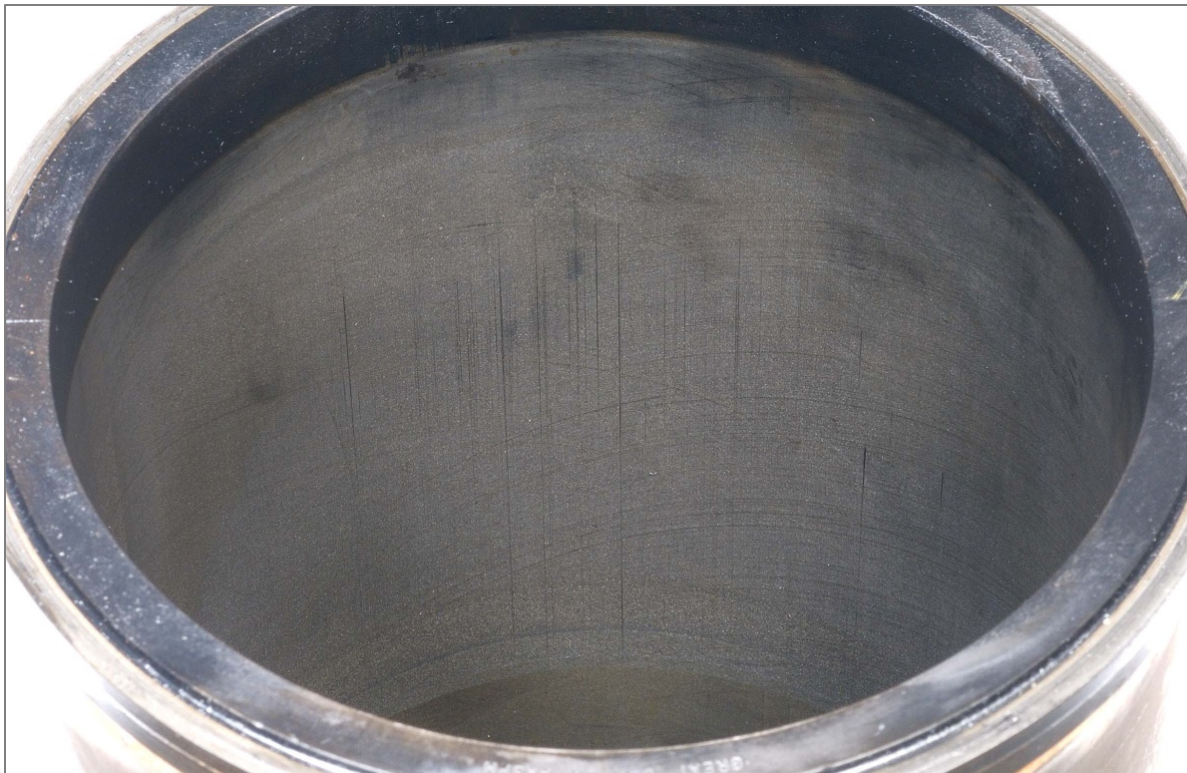
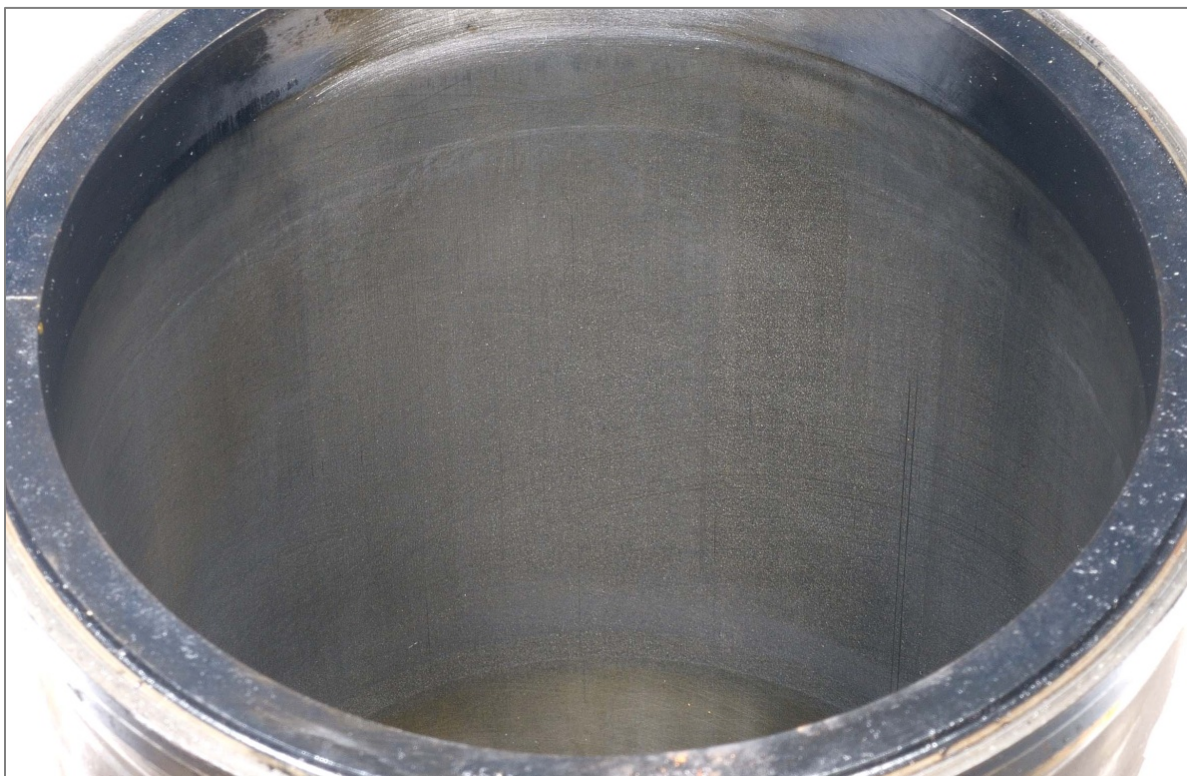
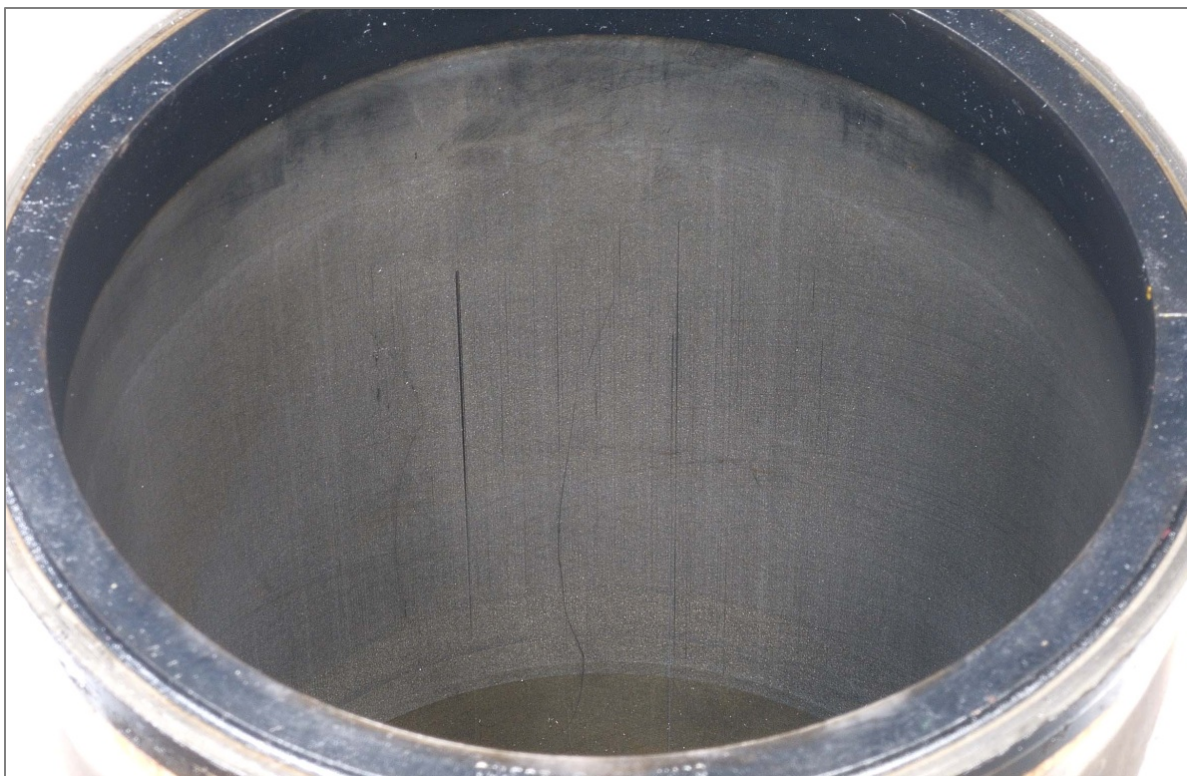
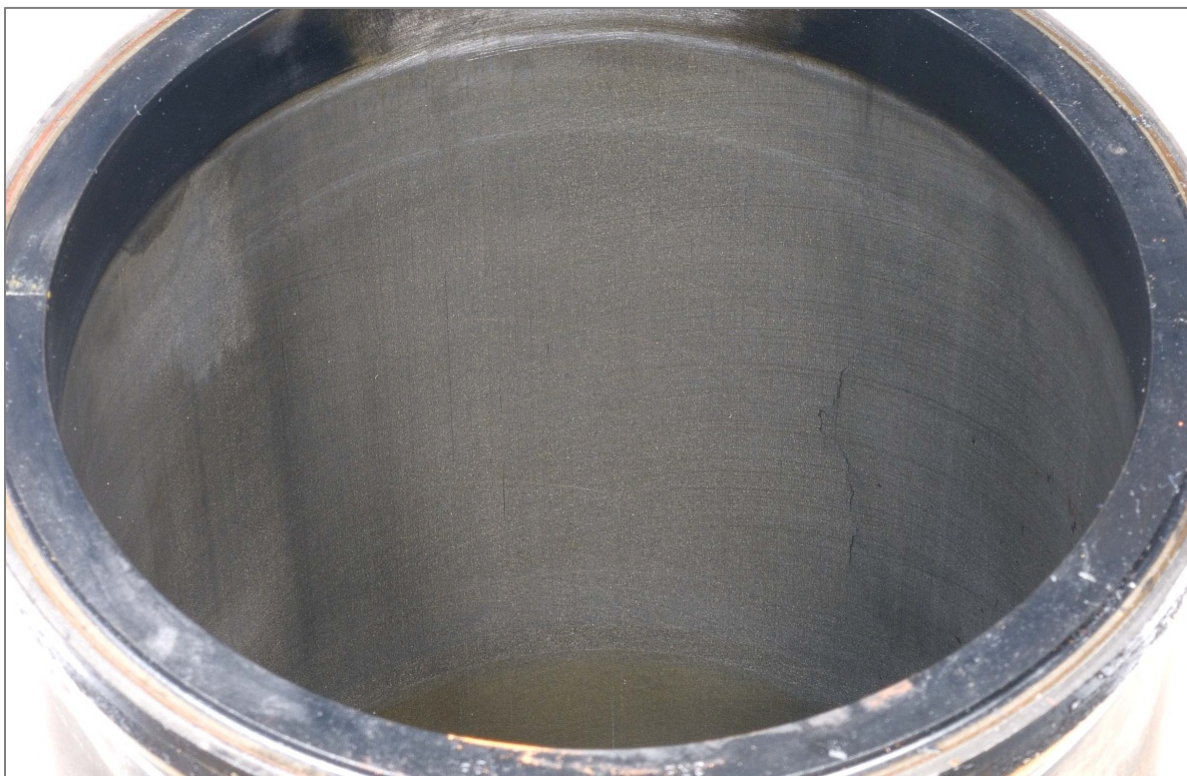
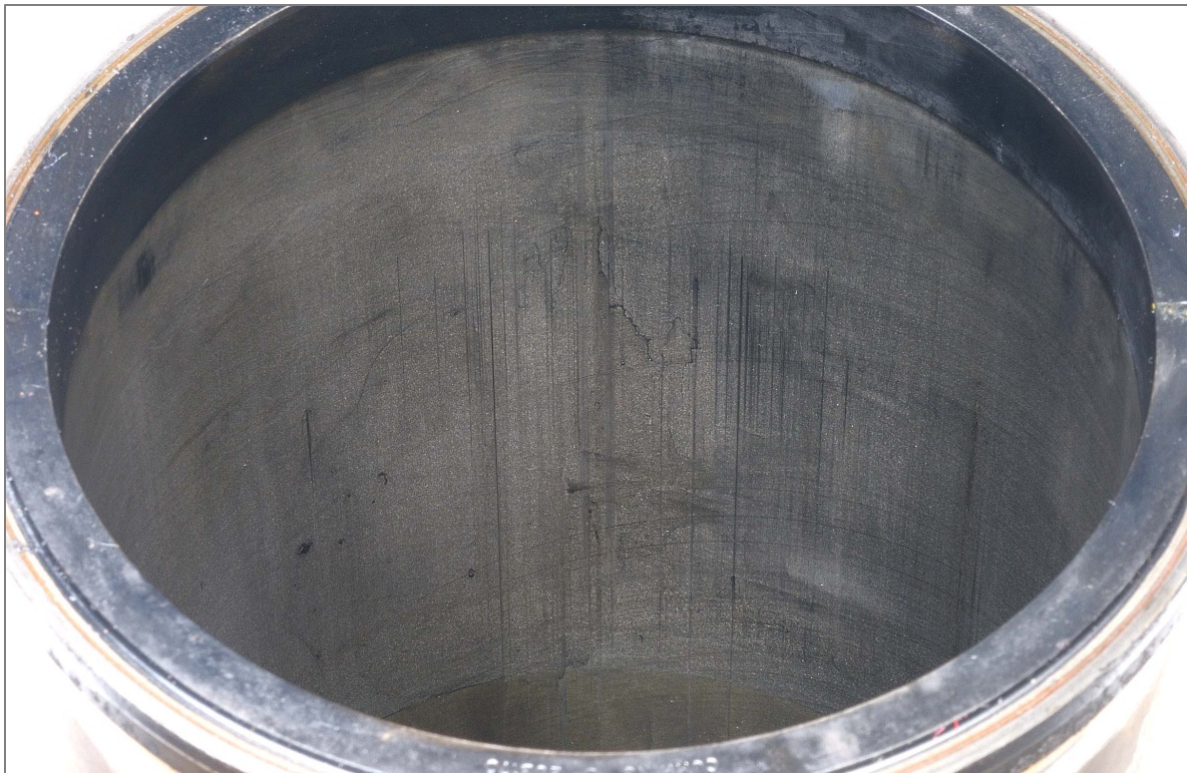
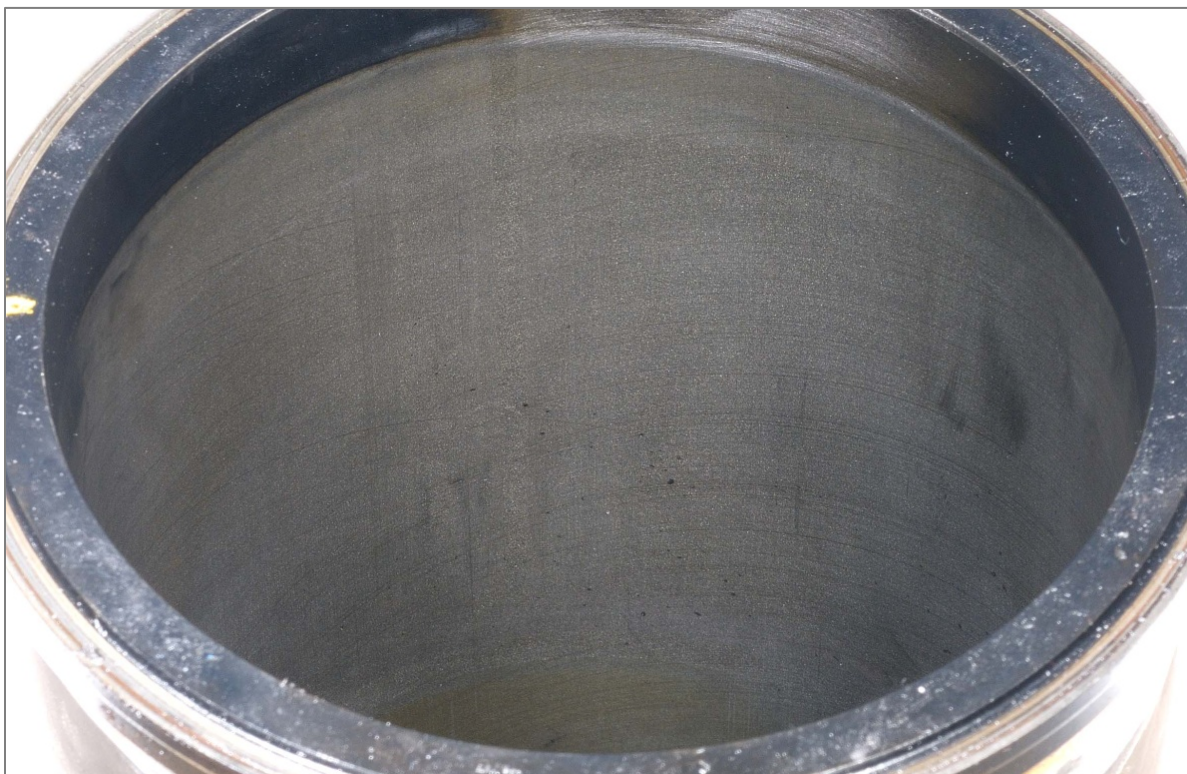
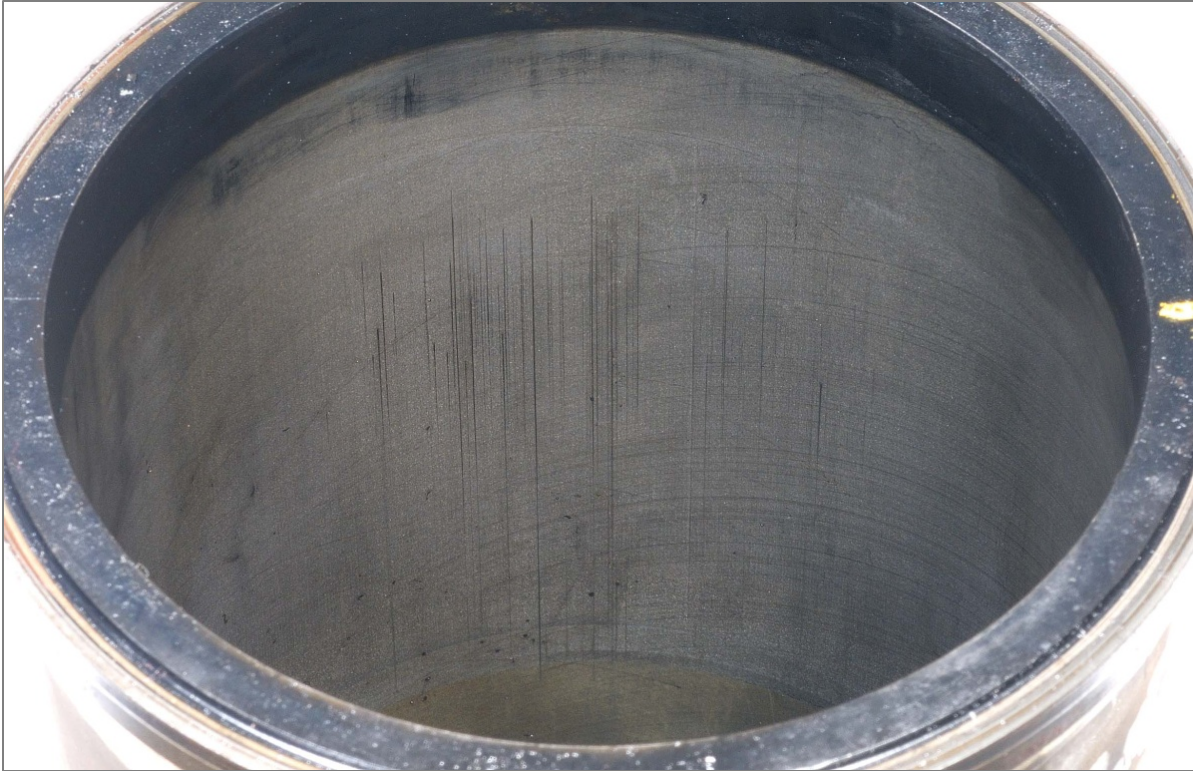
Each liner bore was photographed along its thrust and anti-thrust surfaces for comparison, and are shown in Figure 6 through Figure 21. Each is labeled to identify its location (i.e. cylinder number) on the engine. As seen in the ratings results, none of the individual liners showed evidence of scuffing or bore polish. All lines showed light vertical scratches consistent with normal operation.

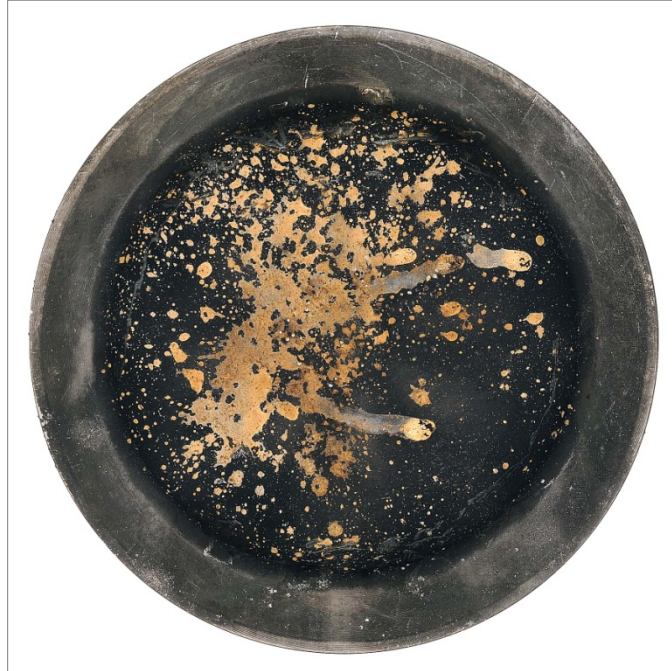
**Figure 28. Piston Crown, Cylinder #2**

Note, rust/water markings shown in the bowl of the number two piston looks to have occurred during the length of storage.
